THE SPARK THAT TAKES LIFE

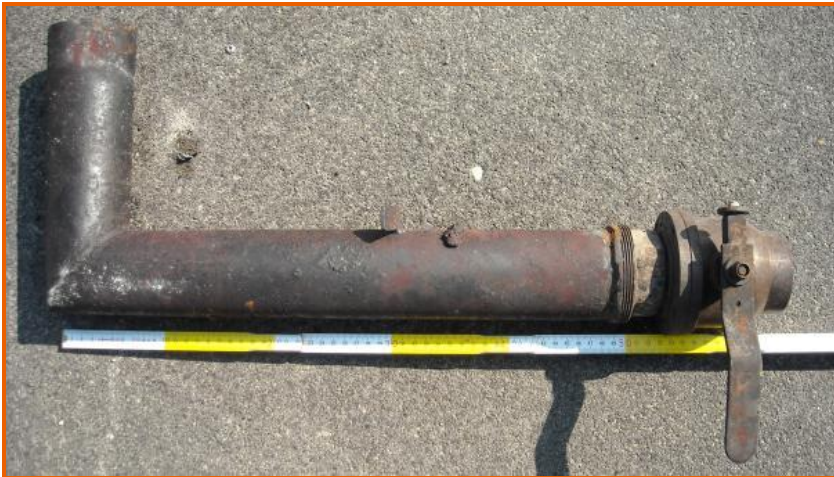
The worker lifted the 1000 litre tank with the forklift truck and, then dismantling the forklift, he inserted a connector into the safety valve of the tank (figure 1). During this operation, the valve came out of its housing, causing a significant spillage of paint.

Figure 1. Detail of the connector and valve

Although the containers were "sealed", handling them turned out to be a very critical operation. During the manual insertion of the connector, the cistern valve came out, causing the paint to pour out. The paint contains 50-75% of butanone, a highly flammable substance whose vapours mixed with air are explosive.

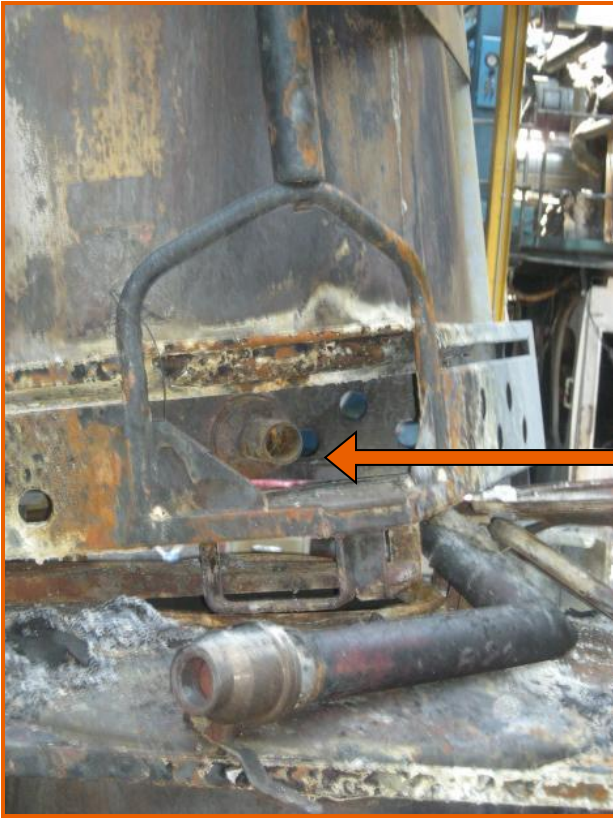
Figure 2. Tank opening without the valve

The first factor causing the accident, from a temporal point of view, was the ejection of the tank valve.
