THE SPARK THAT TAKES LIFE

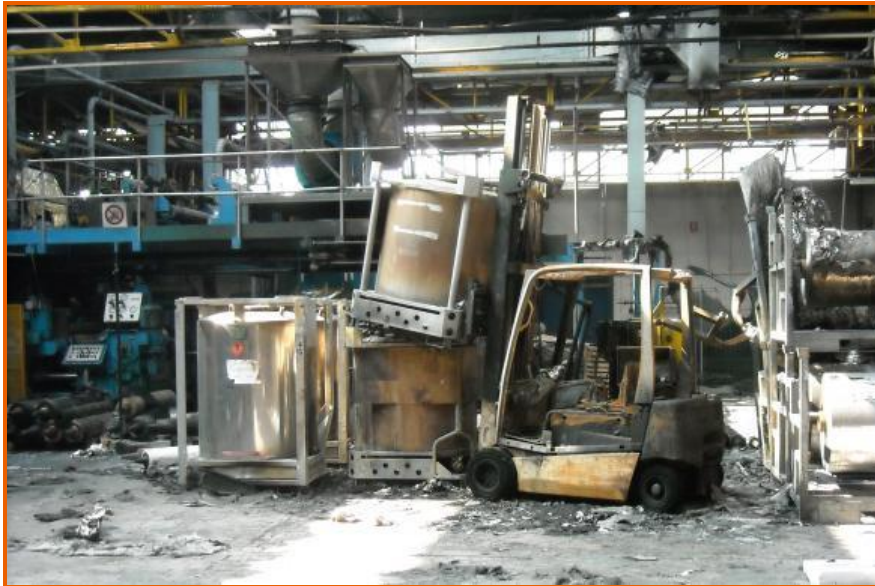
The vapours caught fire due to a spark caused by starting up the forklift that was holding up the tank. The flames spread rapidly hitting three workers.

The second was the use of a forklift unsuited to operate with a risk of explosion.

During the manoeuvres that lead to the event, a forklift truck without flameproof characteristics was used, even though some forklifts with ATEX characteristics were available in the plant (and in the department) and even if a company procedure existed that foresaw its use for such an operation.

There was also no procedure (how to do) nor related equipment (with what to do) to effectively contain any significant spills.

- the company and its workers were not ready to face the situation that had resulted from the significant paint spillage. The risk assessment for the formation of explosive gases must consider the most extreme conditions that the quantities of hazardous preparations and their processing may involve. Only in this case can the organisation adopt adequate prevention and protection measures;

- the procedures adopted for the paint transfers were inadequate considering the high frequency with which they occurred and the quantities of paint being processed. Work at high risk, such as the transfer of significant quantities of hazardous preparations, must be carried out in special rooms by dedicated personnel, in order to reduce the risks but also limit the effects of any incidents;
